ENVIRONMENTAL SURVEY AND ASSESSMENT OF GATEWAY ARMY AMMUNITION PLANT

ENVIRONMENTAL SCIENCE AND ENGINEERING, INC.
Post Office Box ESE
Gainesville, Florida 32602

FINAL REPORT
June 1982

U.S. ARMY TOXIC AND HAZARDOUS MATERIALS AGENCY
Aberdeen Proving Ground, Maryland 21010

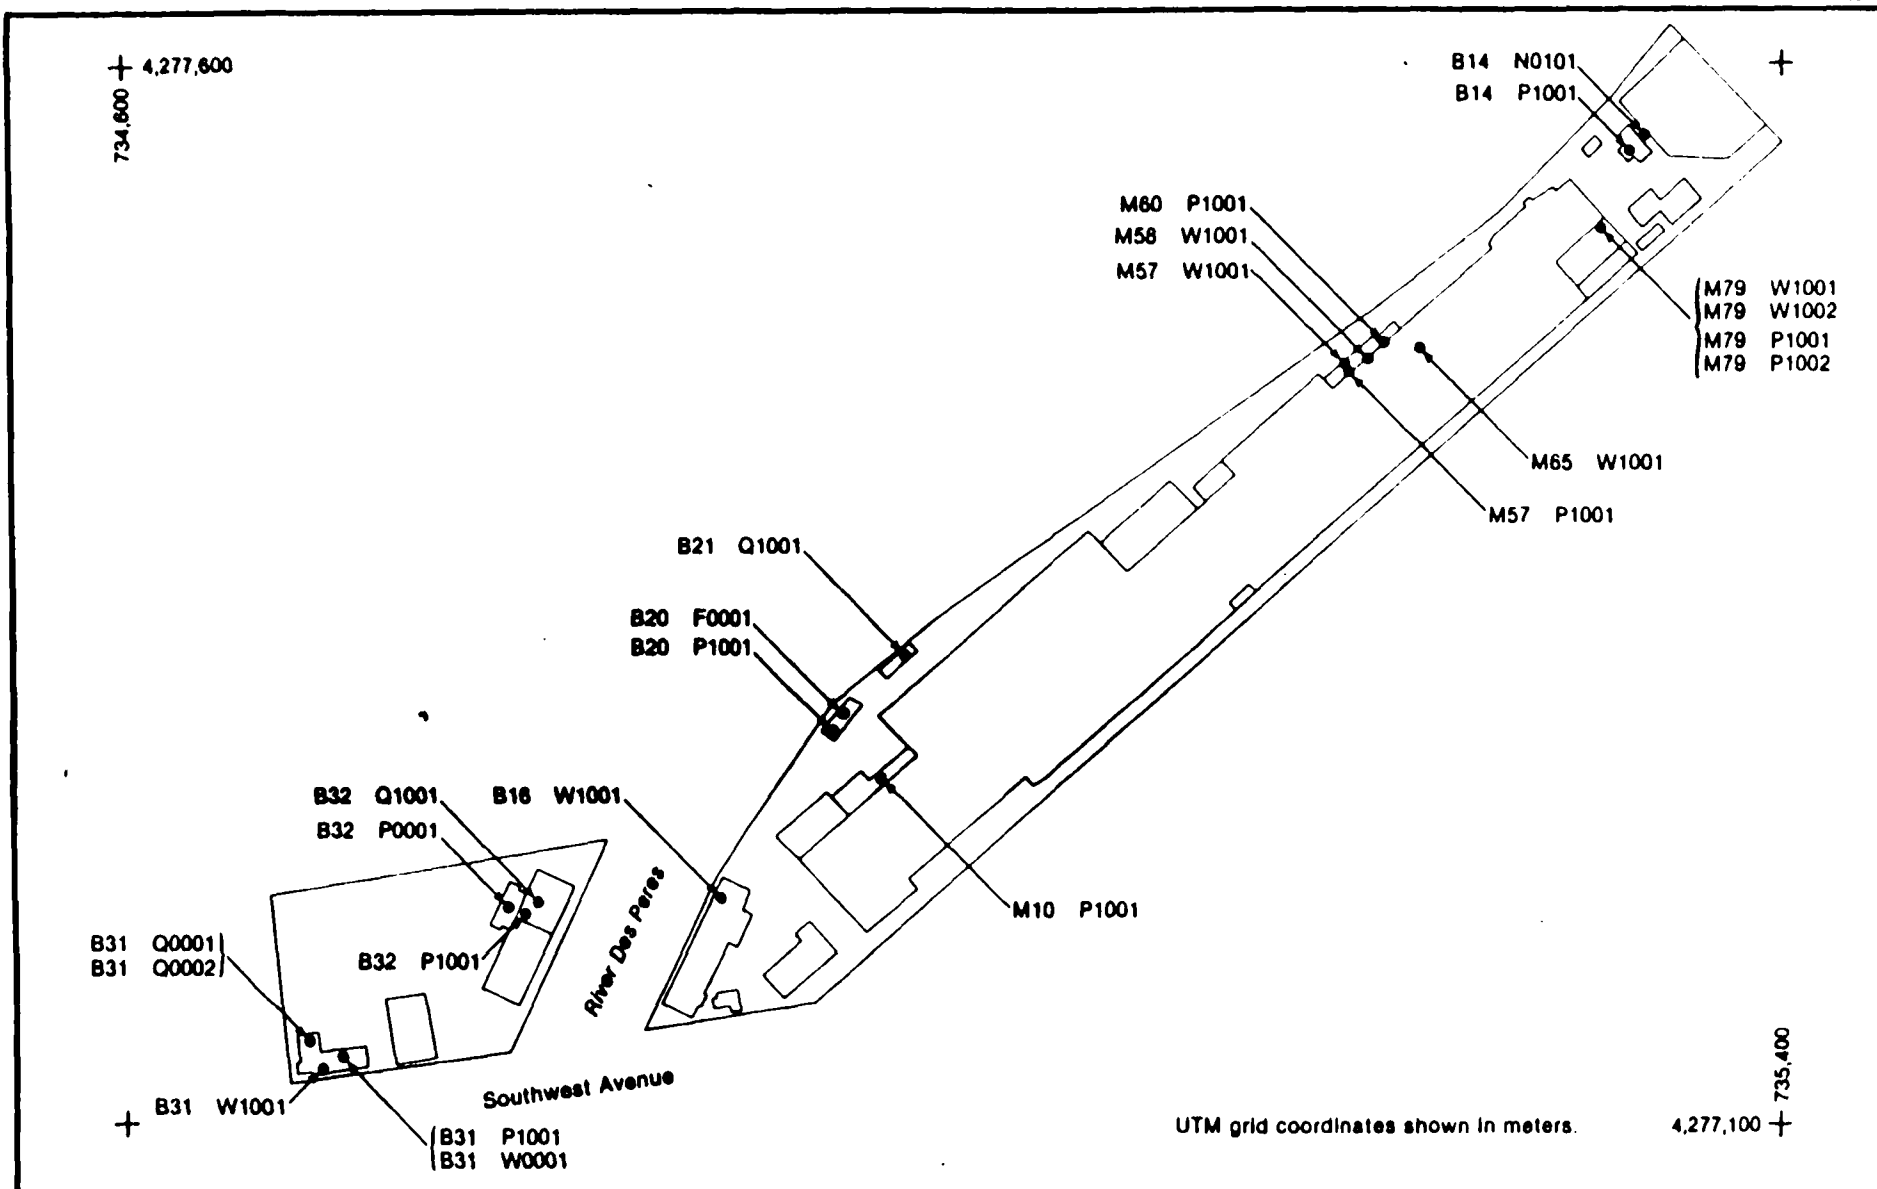
Figure 3-1
SAMPLING LOCATIONS FOR LEAD IN PAINT AND ASBESTOS IN
INSULATION

Many of the buildings contain significant areas of peeling paint. Exceptions are Buildings 21, 25, 18, and 47. In the occupied buildings (Buildings 16, 31, and 62), the areas which are in use are relatively free of peeling paint and in good repair. Unused portions of these buildings contain numerous areas of peeling paint. Section 4.0 presents a detailed inventory of the location of peeling paint in each building. The amount of peeling paint was estimated to constitute less than one percent of the painted areas of the installation overall.

The paint samples contained 0.09 to 2.75 percent lead; therefore, it is probable that all or nearly all peeling paint at GAAP exceeds the Consumer Product Safety Commission criterion for unrestricted use. No such criterion exists for paint used in industrial applications. Areas of GAAP where paint is not peeling are suitable for industrial use with no action with respect to existing painted surfaces. Areas where peeling paint occurs could present an exposure hazard in terms of airborne lead which is regulated to a maximum concentration in air of 0.15 milligrams per cubic meter (mg/m^3) as a time-weighted average (TWA) in the working environment, according to the American Conference of Governmental Industrial Hygienists (USATHAMA, 1981b). If not removed, lead dust exceeding this limit could be generated during removal of peeling paint, renovation, or during future industrial activity. Undisturbed, the peeling paint does not release significant lead; no detectable lead was observed during the air monitoring phase at GAAP (see Section 3.6). Areas where paint containing lead is peeling are suitable for industrial use as long as an airborne lead hazard is

In order to release GAAP for use restricted to industrial operations or activities, all peeling paint which must be removed, should be removed in accordance with sound Occupational Health and Safety Agency (OHSA) practices and disposed into a hazardous waste landfill. Such removal practice includes monitoring the airborne lead content and worker protection measures of wearing respirators, coveralls, and caps. OSHA regulations applicable to permissible airborne lead concentrations and worker protection are contained in 29 CFR 1910.1025. Paragraph (c) of the regulation specifies permissible lead levels; worker protection requirements are described in paragraphs (f) (respiratory protection) and (g) (protective work clothes and procedures).

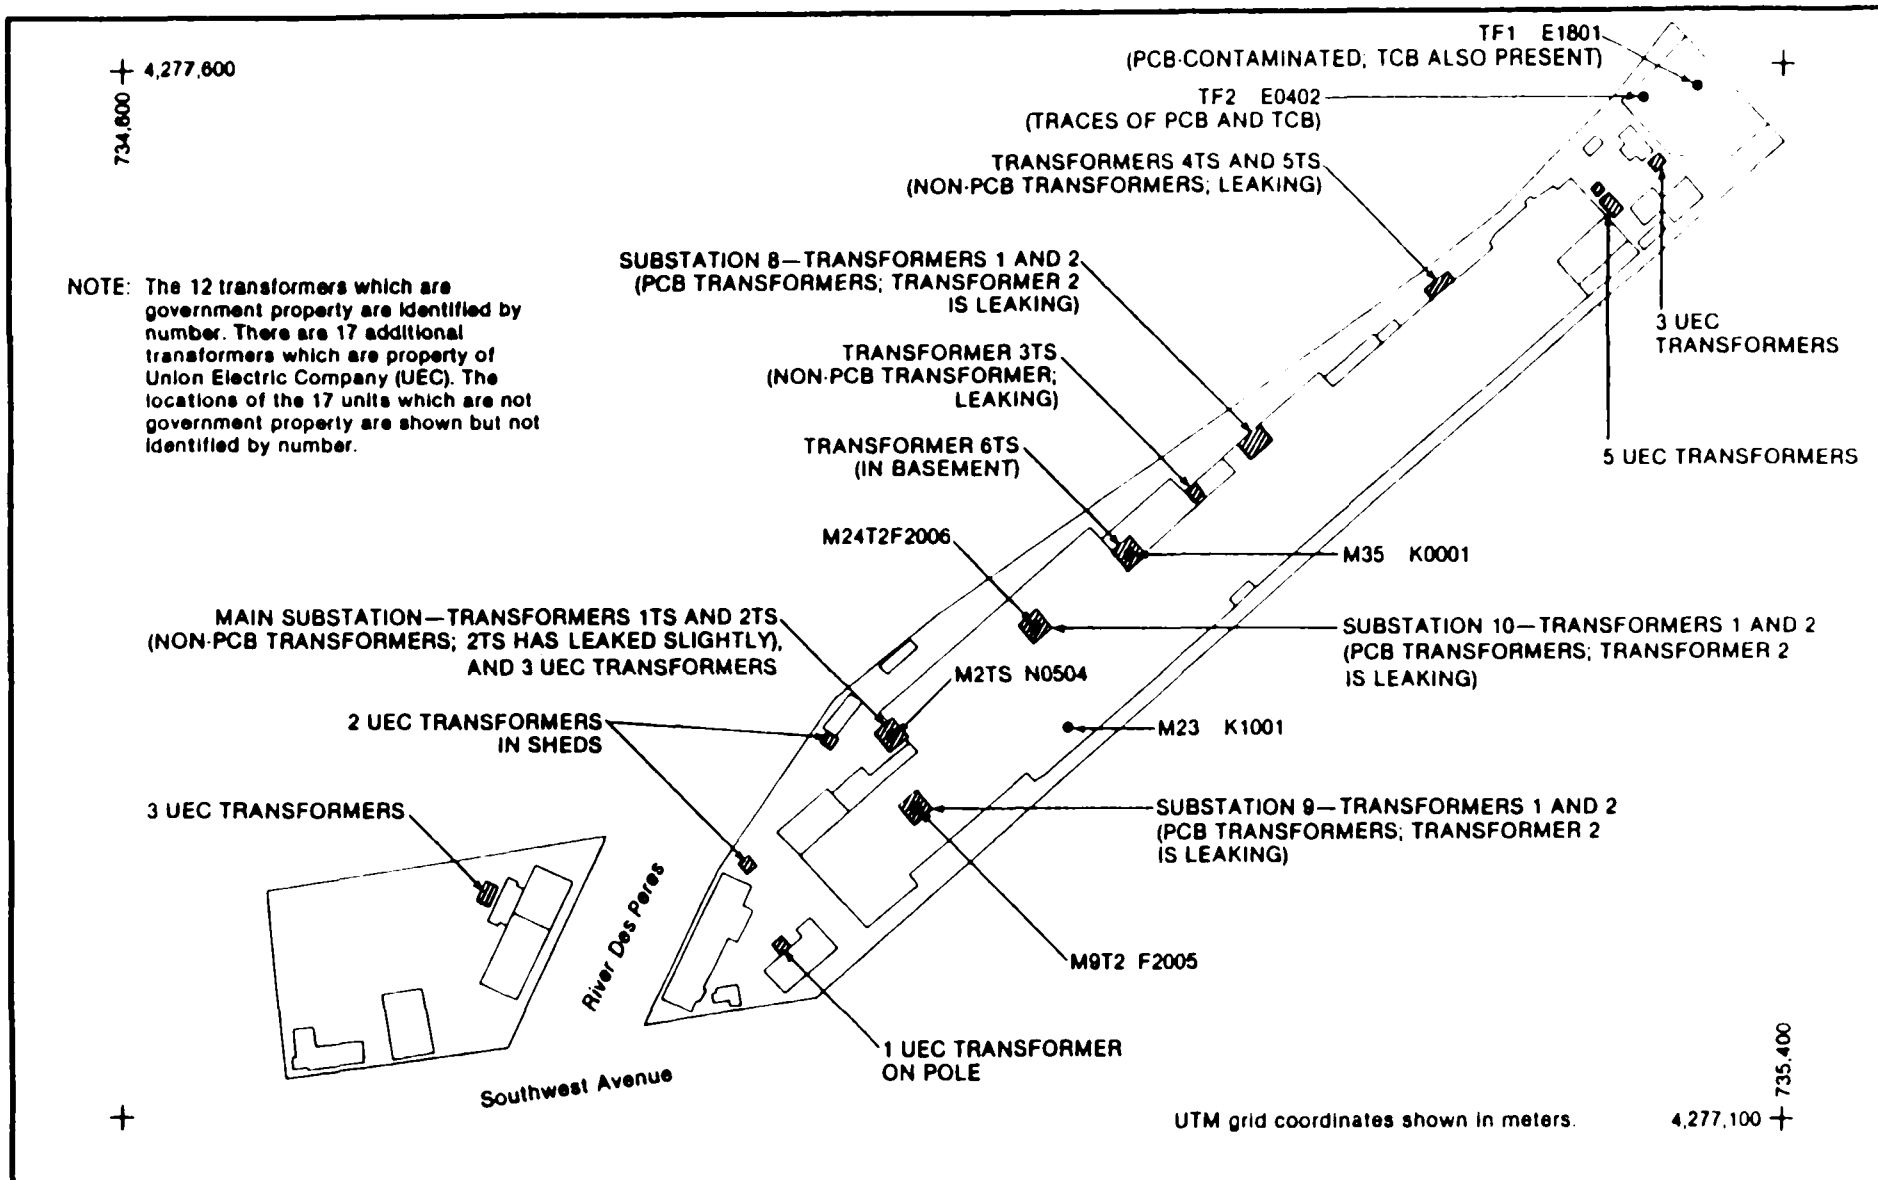
Figure 3-2
LOCATION OF ELECTRICAL TRANSFORMERS AND PCB AND TCB
SAMPLING LOCATIONS

An inventory and inspection of all transformer locations at GAAP was made as a part of the survey in order to determine whether any of the in-service equipment was leaking. At present, there is no out-of-service electrical equipment at GAAP. A total of 12 transformers at the installation are U.S. Government property. At present 17 transformers, all located outside of the GAAP buildings, are the property of Union Electric Company (UEC). The locations and designations of this equipment are shown in Figure 3-2.

The results of analysis and inventory therefore show that in-service (but de-energized) transformers at GAAP contain PCBs and TCB and that these compounds are leaking in the Main Manufacturing Building. The leaking transformers constitute improper use of PCB-containing equipment (EPA, 1979b) (44 Federal Register, 31514-31568) because the PCBs are not being used in a totally enclosed manner. Leakage also constitutes improper disposal of PCB. Results of the survey indicated that none of the UEC transformers are leaking, their PCB status is unknown; however, they do not need to be analyzed as long as they are in-service. Up-keep and removal are the responsibility of UEC. Leaking transformers which are the property of the U.S. Government must be repaired and the leaked material cleaned-up, containerized, labeled, and disposed of in accordance with regulations in Federal Register, 45(98):31530-31532 and 31543-31548 (EPA, 1980). In-service PCB transformers must be labeled in accordance with EPA regulations and inspected monthly for leakage.

Cleanup requirements for the U.S. Government transformers at GAAP, therefore, are to label and properly transport PCB and PCB-contaminated transformers in accordance with EPA regulations after repairing all leaking items. These items must be transported in accordance with Department of Transportation (DOT) requirements which call for packing the items in absorbant, inspection every three months, and labeling the container with EPA-approved PCB labels and as DOT classifications ORM-E.

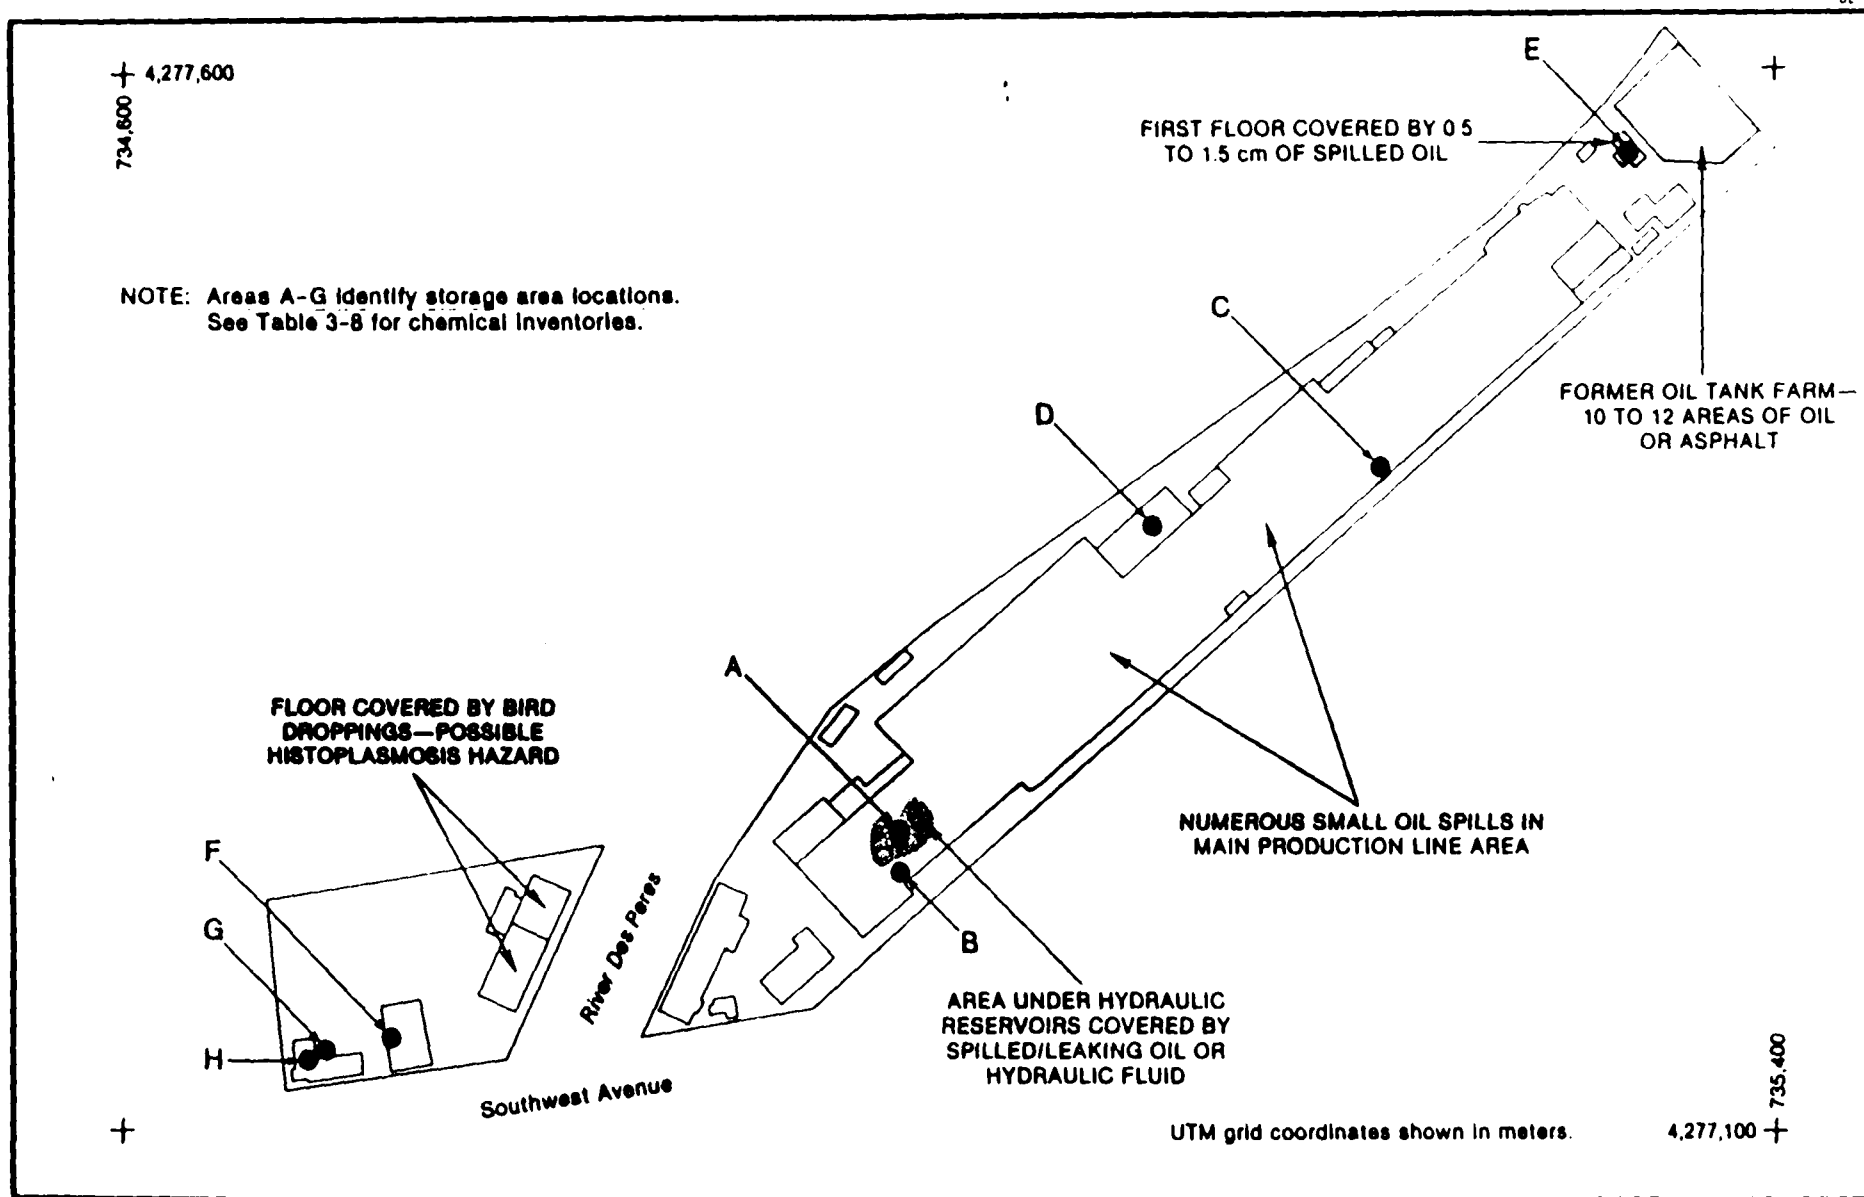
Figure 3-4
LOCATIONS OF POL AND CHEMICAL STORAGE AREAS AND
SIGNIFICANT SPILLS

It was reported that spills and leaks have occurred from storage of fuel oils at the Former Oil Tank Farm. In addition, hydraulic metal-forming equipment removed from the Main Manufacturing Building was stored within the bermed areas of the tank farm while awaiting shipment. Two samples of oil-soaked material were collected from the tank farm area and analyzed for metals (see Section 3.4), PCB-1016, PCB-1260, and TCB. These sampling locations, TF1 E1801 and TF2 E0402, are shown on Figure 3-2 and the results tabulated in Table 3-5. Sample TF2 E0402 was collected at the southwest corner of the bermed area near Building 14. This sample was composed primarily of a gravelly soil matrix which was black as a result of saturation with oily material. The other sample, TF1 E801, was a soil matrix which was cemented together by an asphaltic, oily substance.

The overall quantity of PCB-contaminated material cannot be estimated from the present data, since some spills may involve fuel oil rather than PCB-contaminated or PCB oil. The high (approximately 500ppm) concentrations found in sample TF1 E1801 suggest that leaking PCB equipment had been stored in the bermed area.
